**Flood Control Project Maintenance
Levee Inspections**

Fall 2011 Levee Maintenance Deficiency Summary Report

Sutter Maintenance Yard Maintenance Area 0016

Waterway			Bank	Unit Miles
Unit No. 01 Feather River			Right	4.09
	Spring (March - May)	Summer (June - August)	(September - November) Fall	Winter (December - February)
Unit Maintenance Rating (Fall Only)			M	
Date of Inspection	4/19/2011 - 4/19/2011		10/13/2011 - 10/13/2011	
DWR Inspector	Clay Thomas		Clay Thomas	
Accompanied By	Jason Cooper		Jason Cooper

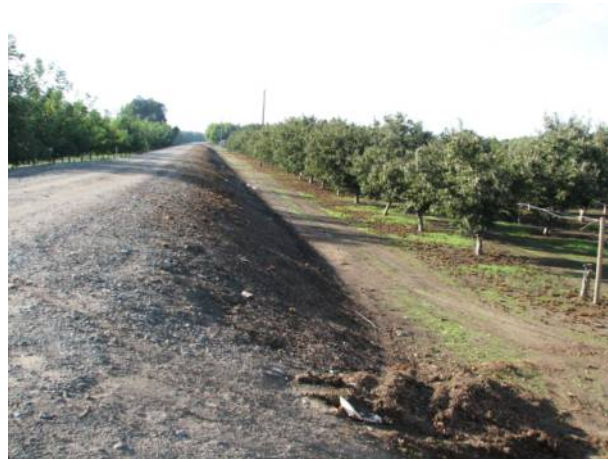
Levee Mile Report Line	1
Start Levee Mile	0.00
End Levee Mile	4.07
Location	Land Side
Category	Earthen Levee
Item	Vegetation

This photo shows the landside vegetation at levee mile 4.07 looking downstream.

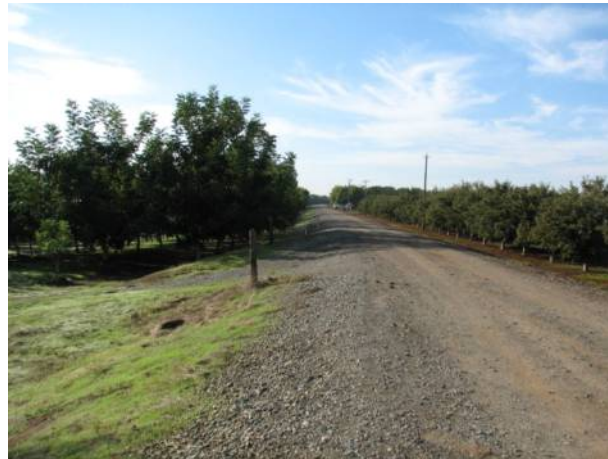
Levee Mile Report Line	2
Start Levee Mile	0.00
End Levee Mile	4.07
Location	Water Side
Category	Earthen Levee
Item	Vegetation

This photo shows the waterside vegetation at levee mile 4.07 looking downstream.

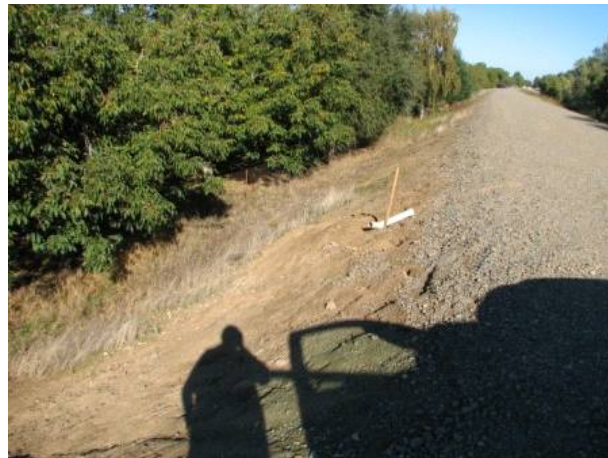
Levee Mile Report Line	3
Start Levee Mile	0.01
End Levee Mile	0.01
Location	Land Side
Category	Earthen Levee
Item	Animal Control

Levee mile 0.01, View of squirrel holes along the slope.

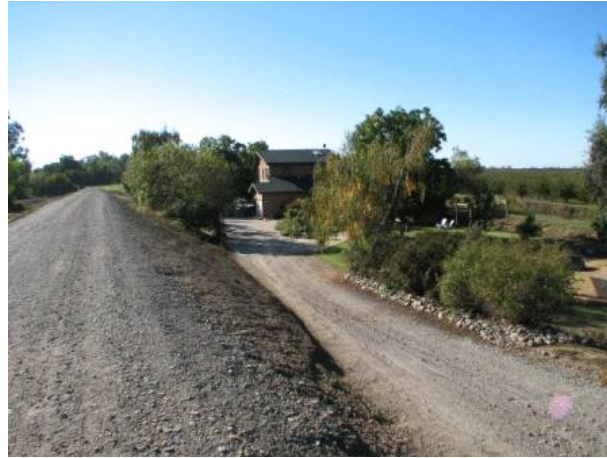
Levee Mile Report Line	4
Start Levee Mile	0.06
End Levee Mile	0.10
Location	Land Side
Category	Earthen Levee
Item	Encroachments

Levee mile 0.10. This photo shows the landscaping on the landside slope and toe.

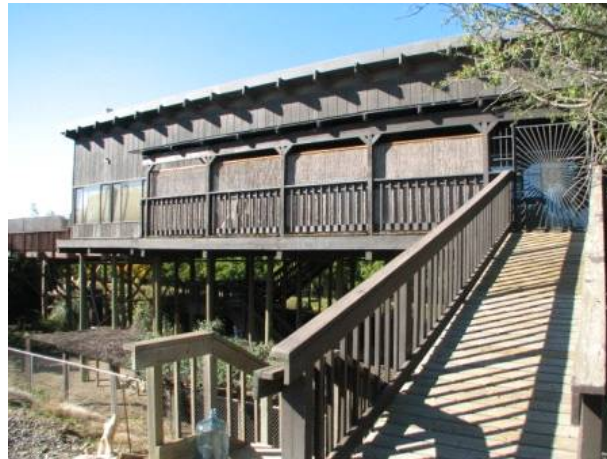
Levee Mile Report Line	5
Start Levee Mile	0.18
End Levee Mile	0.18
Location	Land Side
Category	Earthen Levee
Item	Encroachments

Levee mile 0.18. This photo shows the building on the landside shoulder and toe.

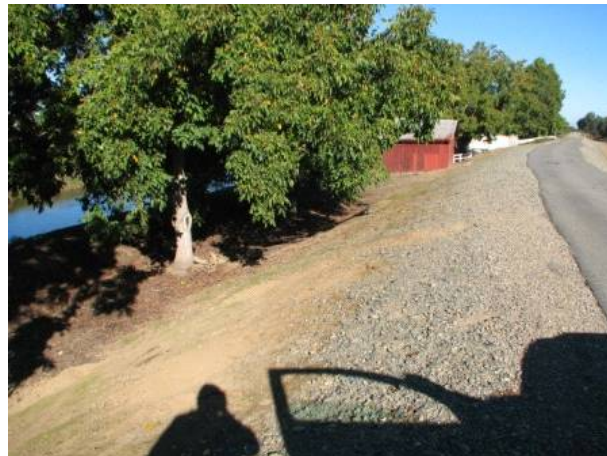
Levee Mile Report Line	7
Start Levee Mile	0.39
End Levee Mile	0.39
Location	Land Side
Category	Earthen Levee
Item	Animal Control

Levee mile 0.39. View of squirrel hole along the slope.

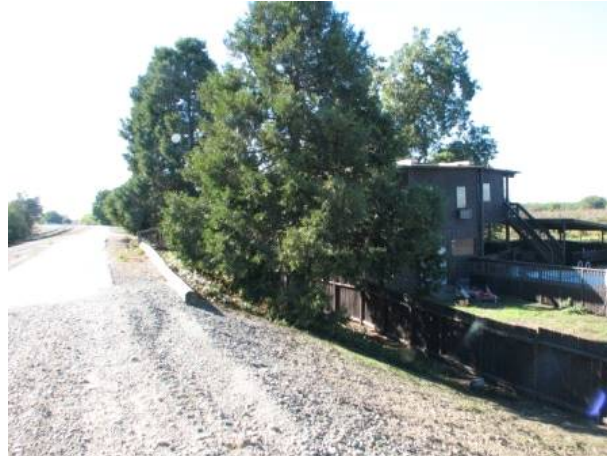
Levee Mile Report Line	8
Start Levee Mile	0.45
End Levee Mile	0.49
Location	Land Side
Category	Earthen Levee
Item	Encroachments
Levee mile 0.49. This photo shows the building and landscaping on the landside slope and toe.	
cathom_f_20111010_771.jpg

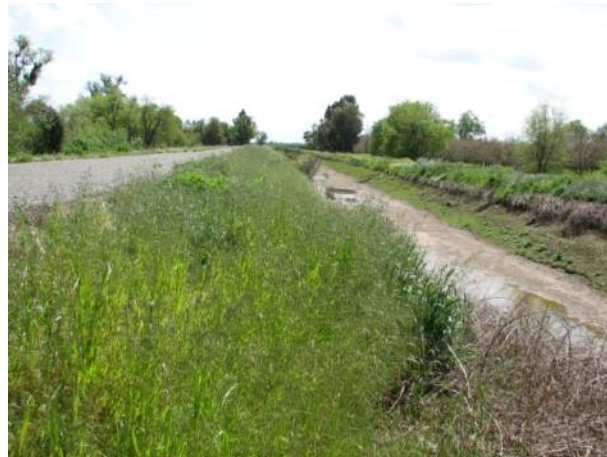
Levee Mile Report Line	10
Start Levee Mile	2.85
End Levee Mile	3.08
Location	Land Side
Category	Earthen Levee
Item	Encroachments
Land side ditch levee mile 3.08.	
cathom_f_20111010_772.jpg

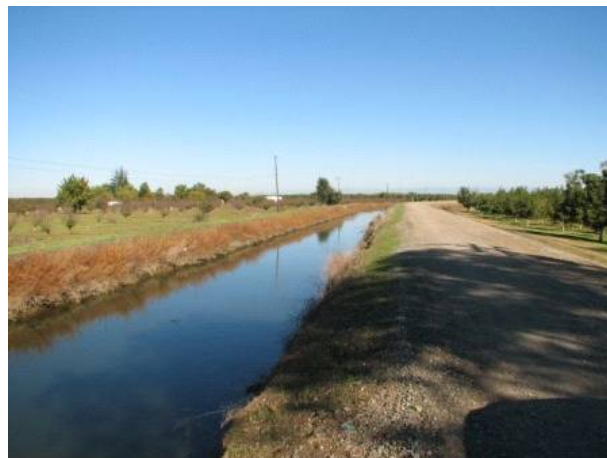
Levee Mile Report Line	10
Start Levee Mile	2.85
End Levee Mile	3.08
Location	Land Side
Category	Earthen Levee
Item	Encroachments
AG ditch land side slope and toe.	
cathom_f_20111010_773.jpg
